Causes of Structural Failures with Steel Structures

Göran Alpsten

Stålbyggnadskontroll AB, Stocksund, Sweden (formerly Adjunct Professor in Steel Construction, The Royal Institute of Technology KTH, Stockholm)

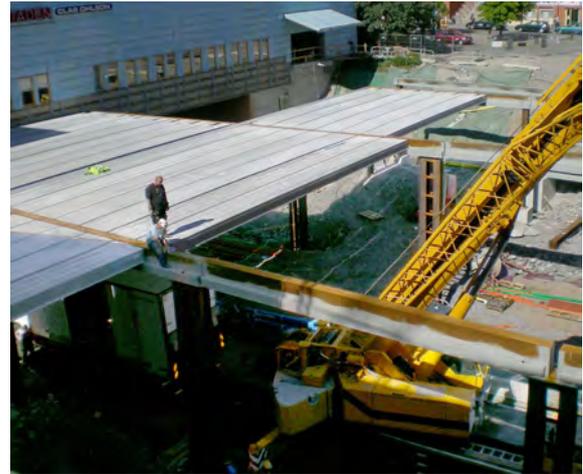
Figure 1. Commercial center building under construction, view half an hour before structural collapse

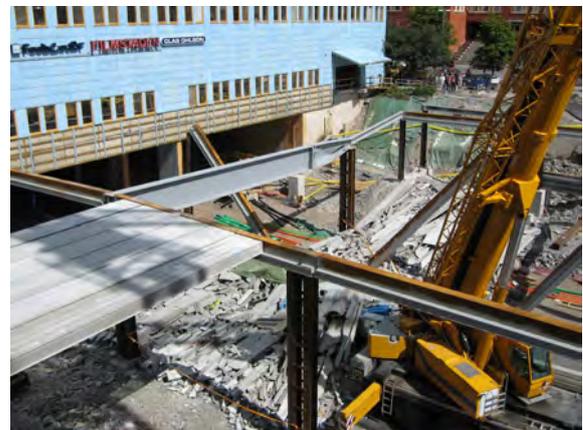
Figures 1 and 2 show a view of the floor deck before and after the failure. The structural member causing the failure is the welded 1400 mm high I-girder visible in the center of Figure 2, introduced in the structural frame in the planning of the building because the column to the right of the I-girder had to be relocated from the normal system grid, the I-girder providing intermediate supports for deck girders in the perpendicular direction.

Figure 2. Same view as in Figure 1, after collapse

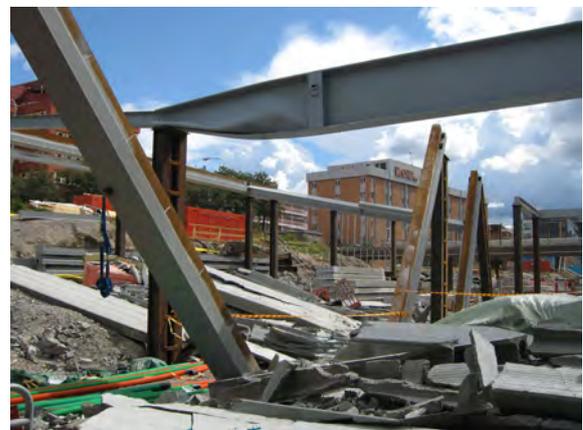
The I-girder was designed using a computer program. When transferring the dimensions obtained from the program to the drawings, the throat thickness of the fillet welds was confused for the web thickness. Thus the web thickness as specified on the drawings of the 1400 mm high I-girder was 7 mm, instead of at least 12 mm required from a correct design. However, a further gross human error was introduced in that no web stiffeners were provided over the right-end column support.

Figure 3. Welded 1400 mm high I-girder which initiated the structural collapse shown in Figure 2

Figure 3 shows the deformed I-girder after the collapse, the fallen perpendicular deck girders and prefab deck elements fallen to the ground.

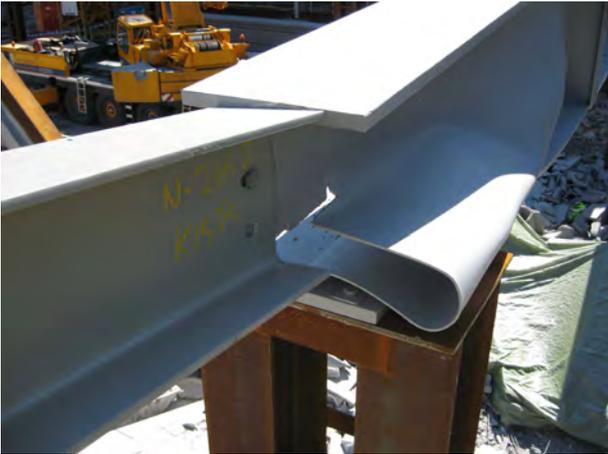
Figure 4. Local buckling of the web of the I-girder over the column support, where web stiffeners are lacking

The typical local buckling behavior of the overloaded web of the I-girder over the column support where web stiffeners are lacking is visible in Figure 4.

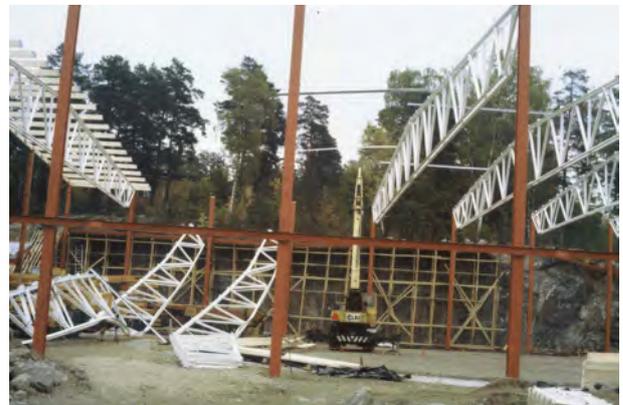
The collapse during construction of the steel structure shown in Figures 5 and 6 is representative of a class of failures where human error has been made in failing to provide conditions for full stability of the structure during the complete construction phase. The building in this case is a track and field sports arena with roof trusses spanning 50 m.

However, the next subcontractor, engaged for the erection of the roof structure consisting of laminated wood purlins and a plate roof, had problems due to the temporary bracing elements hindering movements of the crane used to lift the roof material. Negligent of the important purpose of the temporary bracing elements, the subcontractor loosened them one by one, until the two trusses now without intermediate lateral supports collapsed due to lateral-torsional buckling. The action to remove temporary bracing without reflection should be considered a gross

Figure 5. Roof trusses collapsed during construction when roof structure is being erected

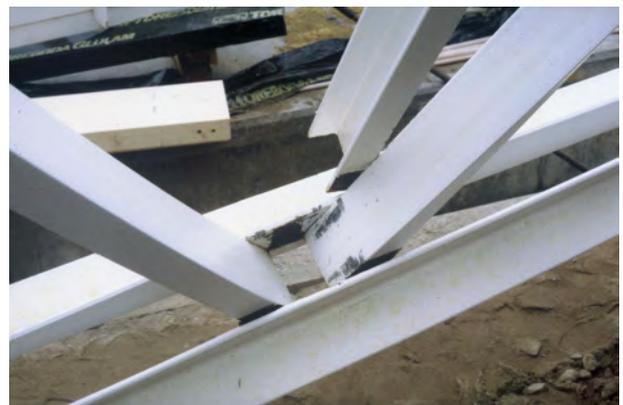
Figure 6. Joint in collapsed roof trusses from Figure 5, with some fractured welds

In some joints of the trusses the welds were fractured after the collapse, see Figure 6. It is in cases like this easy to jump to the conclusion that defective welds are the cause of the collapse. In fact, in the case of Figures 5 and 6 an experienced weld inspector had made up an initial report that defective welds in the joints of the trusses were the probable cause of the collapse. However, it is easy to verify that these 50 m trusses when no side support is provided will fail by lateral-torsional buckling when subjected to their own weight only. The fractured welds are a consequence of the trusses being subjected in the fall to unforeseen weak axis bending, possibly also by dynamic effects when hitting the ground. The normal collapse mechanism in this class of collapses is instability in some form, such as column buckling, lateral-torsional buckling or local buckling.

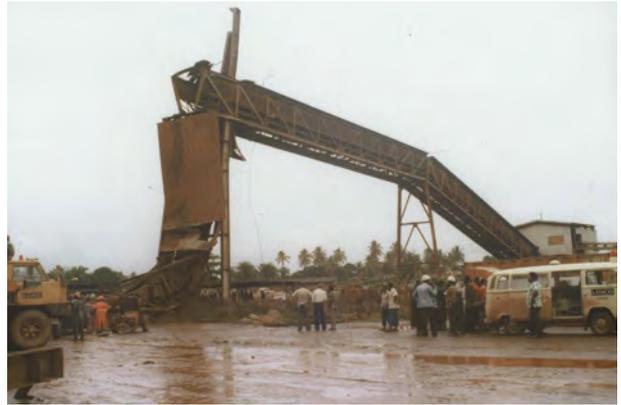
The most serious of the collapse cases investigated by the writer in terms of the consequences is that of a conveyor belt gallery, Figure 7. In this case two persons were killed and great economical losses were made due to a long interruption in the production. Part of the steel structure fell down some 30 m to the ground, with instability effects to some members and fractures in others, Figure 8.

Figure 7. Collapsed conveyor belt gallery

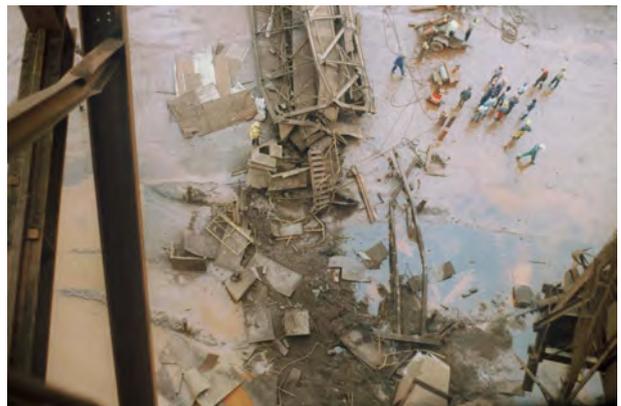
Figure 8. Remains from collapsed conveyor belt gallery seen from a 30 m level in process building

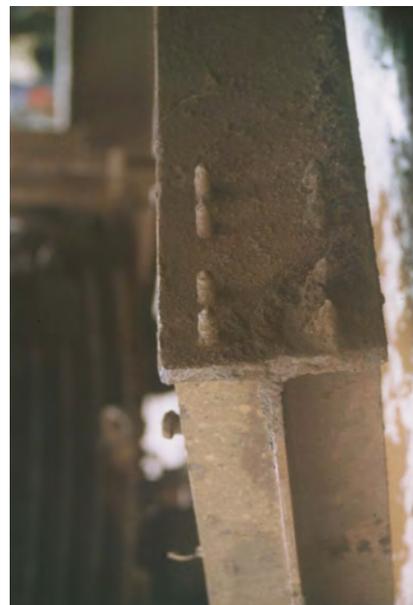
The main reason for the collapse was corrosion damage internally in a bolted joint carrying a steel cross-beam in which the conveyor belt gallery was hanging at its upper end in a process building, see Figure 9. Only a small portion of the cross-sectional area of the bolts were remaining at the time of the collapse. This collapse could be attributed mainly to the gross human error in neglecting to implement a rational inspection program for regular checks of the status of this structure in a very corrosive environment. The inappropriate design with the cross-beam hanging from supports instead of resting on the supports may also be considered a human error.

Figure 9. Detail of cross beam carrying the conveyor belt gallery in the process building, with bolts loaded in tension and damaged by corrosion

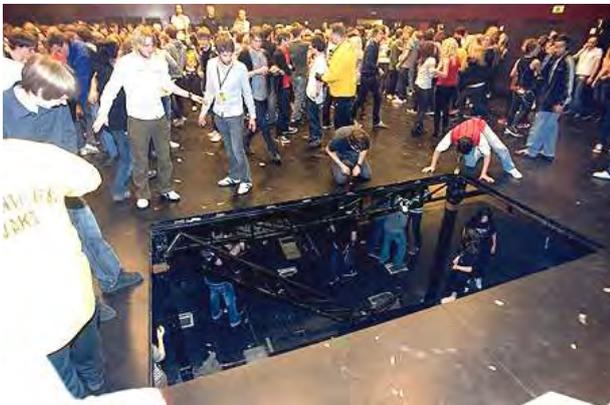
Another example of a failure of a steel structure during service concerns a floor deck in the hall of a building designed for performances and rehearsals of a symphony orchestra, Figure 10. At the time of the collapse the premises were used for a rock concert with 700 youths jumping on the floor in pace with the rock music, instead of the limited number of 250 persons sitting listening to a symphony as assumed in the structural design. When a 4 x 2 m floor section collapsed due to load action on the floor being 2 to 3 times greater than foreseen for the intended service, about 50 youths fell to the floor below, of which 29 had to be treated at the hospital for broken limbs and other injuries.

Figure 10. Collapsed floor deck in concert hall

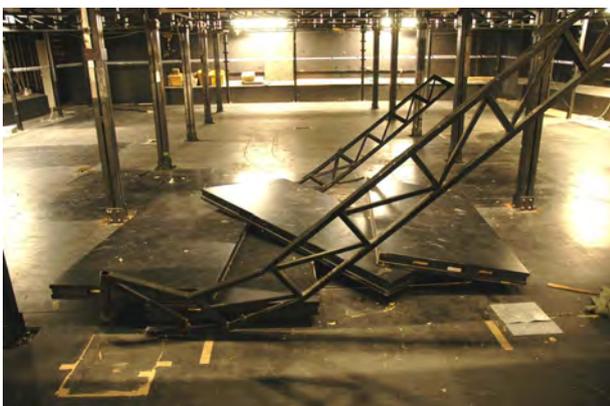
Figure 11. Collapsed steel truss beams in the floor deck of Figure 10

turn may be placed at various heights on steel columns below. This is to make possible various arrangements on the floor, such as preparing an orchestra pit. In the collapse the overloaded trusses fractured in some welds and some members in the trusses collapsed due to instability, Figure 11. Again, the main cause of the collapse is a gross human error, in this case by accepting the premises to be used for activities causing much heavier loads than specified for the design. Too small welds in the trusses may also have contributed to the failure.

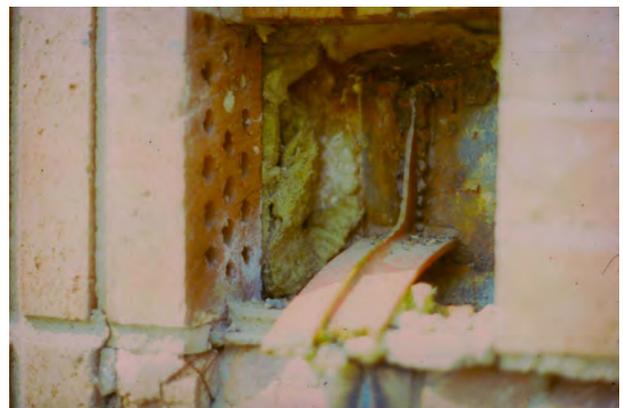
The walls of the building were prepared with insulation and bricks, and openings were left for attaching the cantilever beams as indicated in Figure 12. A welder was then asked to perform the weld attachment of the cantilever beams inside these openings. The welder made a gross human error in that he did not refuse to carry out the welding because of too bad accessibility, especially for the important weld to the upper flange of the beams subjected to tensile forces from vertical loads on the roof. Instead he tried to

Figure 12. Detail of fractured welded attachment of cantilever beams for a roof over walkway

make the best possible workmanship under the present circumstances. This resulted in a weld at the upper flange of the beams to be completely filled with slag inclusions.

Of particular interest in the behavior of the breakdown shown in Figure 12 is that the fracture started as expected in the weld filled with slag inclusions at the upper flanges with tensile forces. However, when the crack propagated into the web of the beams the fracture chose to enter the base material in the beams away from the weld. This was the case even though the weld along the web was far from perfect (it has not even been de-slugged as may be observed in Figure 12).

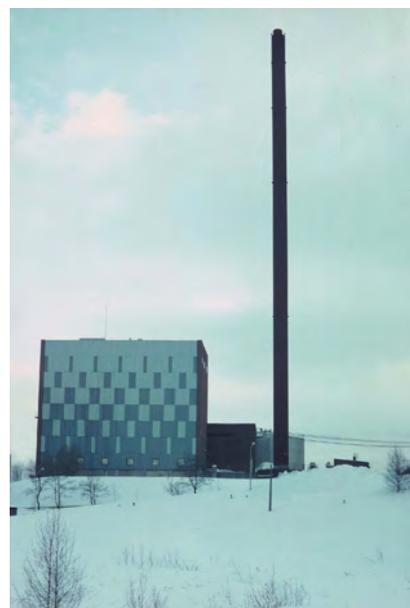
Figure 13 shows an example of a 90 m high steel chimney where fatigue cracks were observed after 12 years of service. The cracks were made visible by magnetic-particle testing, Figure 14. Figures 15 and 16 show an example of a detected crack at the edge between weld passes at the top of the vertical stiffeners, and after grinding down to about half the thickness of the shell plate, respectively. The incident of fatigue cracks in this chimney was to a great extent caused by a gross human error behind the regulations at that time defining load action related to vortex shedding.

Figure 13. 90 steel chimney where fatigue cracks due to vortex shedding were detected at the base

A number of fatigue cracks in the shell and in anchor bolts could be detected in this chimney. As corrective actions the base of the chimney was repaired by adding an outside skirt with new anchor bolts to unload the cracked parts, and in addition the chimney was fitted with helical strakes (Scruton strakes) at the top of the chimney. This chimney has now been in service for many years without further fatigue problems.

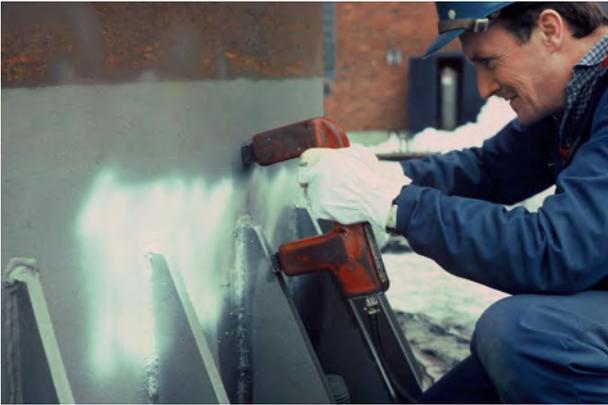
Figure 14. Magnetic-particle testing of welds at the base of the chimney in Figure 13. The lower part of the chimney made of weather-resistant steel has been blast-cleaned before testing

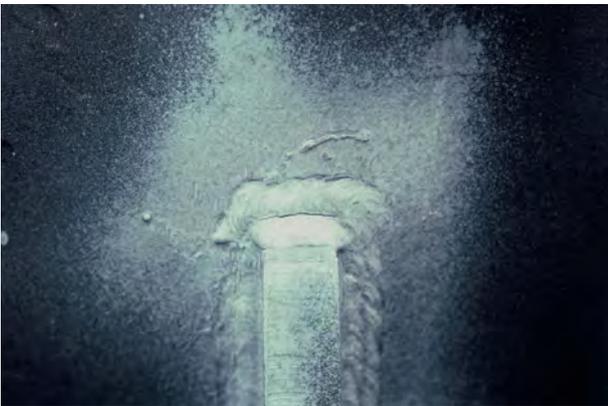
Figure 15. Fatigue crack detected by magnetic-particle testing at the toe between two weld passes around a vertical stiffener at the base of the chimney in Figures 13 and 14

of a weld, that is, at the transition between weld and base material (Figure 18), or at any edges between individual weld passes (Figure 15). Thus, the important criteria for such structures are the quality of the weld toes. Visual inspection, if necessary supplemented by magnetic-particle testing, is the most efficient way to ensure adequate fatigue properties in the production of such structures. This is true also for inspecting existing steel structures with fatigue loading.

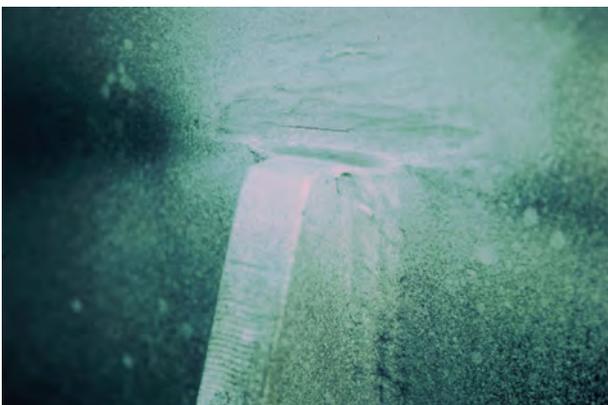
Figure 16. Fatigue crack indicated by magnetic-particle testing after grinding the detail in Figure 15 down to half the thickness of the shell plate

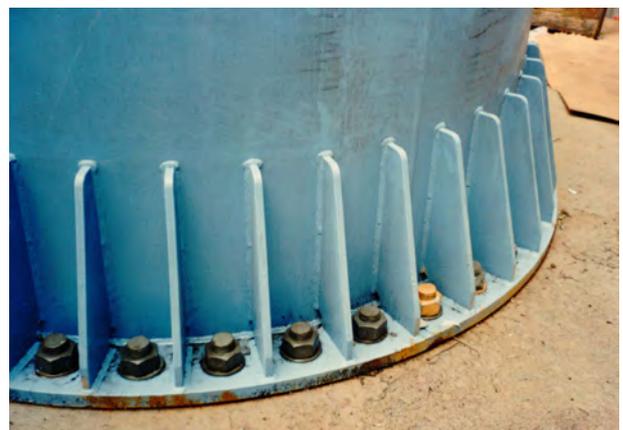
A detail from the base of another 90 m high steel chimney where several fatigue cracks were observed a few months after installation of the chimney is shown in Figure 17 [2]. Most of the cracks were located in the weld toe at the top of the vertical stiffeners, and in some places the cracks were visible even to the naked eye, Figure 18. The position of the cracks at the lower weld toe as evident in Figure 18 is due to the unsuitable design of the stiffeners, causing an even greater stress concentration effect on this side of the weld as compared to the upper weld toe to the shell.

In this case the cause for the undue fatigue damage after a few months of service was a combination of two gross human errors. A mass damper at the top of the chimney was incorrectly installed, which did not reduce large-amplitude oscillations at vortex shedding as expected, and critical details were badly designed, causing unnecessarily grave stress concentrations at the weld toes.

Figure 17. Base of 90 m high chimney with malfunctioning mass damper at the top

The structure was rectified by weld repair of the cracks, correcting the malfunctioning mass damper and finally also providing a supplementary damping device [3].

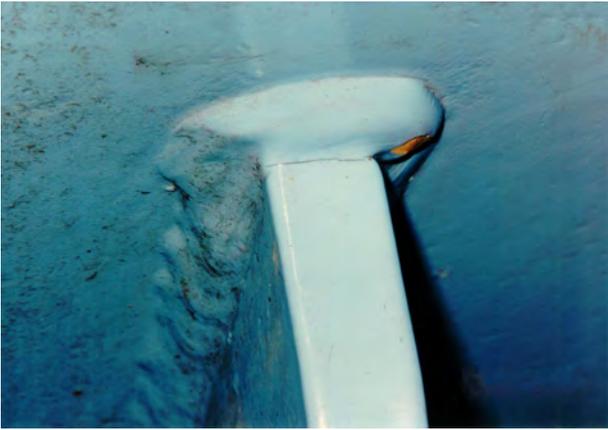
Figure 18. Example of fatigue crack at a stiffener at base of chimney shown in Figure 17, in this case visible in the cracked paint

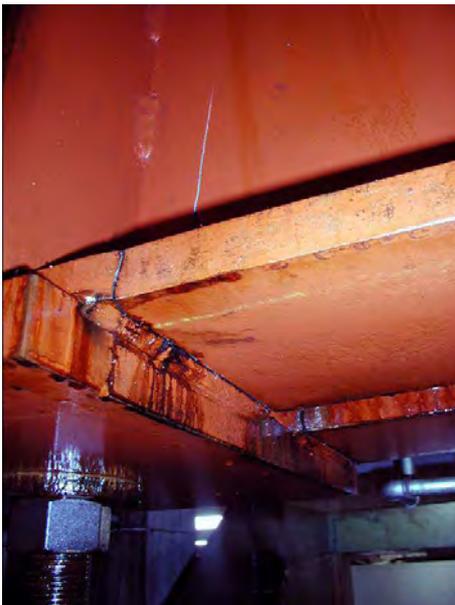
Figure 19. Fatigue cracks in two parallel hot-rolled beams HEB1000, initiated at the weld toe of the fillet weld to the cover plate at the lower flange and then propagating up to half the height of the web of the beams

The beams are connected two and two via cover plates welded to the bottom flange of the beams. Cracks have initiated from the weld toe at the cover plate and propagated into the lower flange of the two beams in Figure 19 and then further into the web, in one of the beams up to half the web height.

Apparently the initial design of this steel structure had not considered any fatigue effects at all. A check analysis of the structure for the actual fatigue loading conditions revealed that the safe fatigue life of the structure had indeed been surpassed. The only surprising thing about this incident is that the steel frame had not collapsed completely. The fact that the structure was still in place with near critical crack lengths is probably due to arch action in the slab.
